# Manhole Inspection Summary

Manhole # S31S1\_002MH

Insp Date: **2/15/08 9:10 AM**

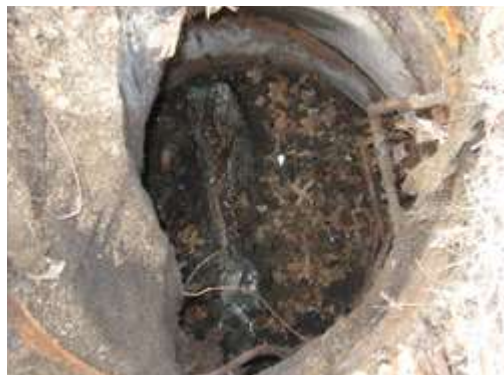
Top View

Condition: ☐ Sound ☐ Cracked ☒ **Root Intrusion** ☐ Loose Brick ☐ Deteriorated

Infiltration: ☐ None ☐ Joint ☐ Cracks ☐ Mortar ☒ **Roots** ☒ **Wall**
